U.S. Environmental Protection Agency

Former Koppers Wood Treating Plant

November 14, 2013

# Remediation at Koppers

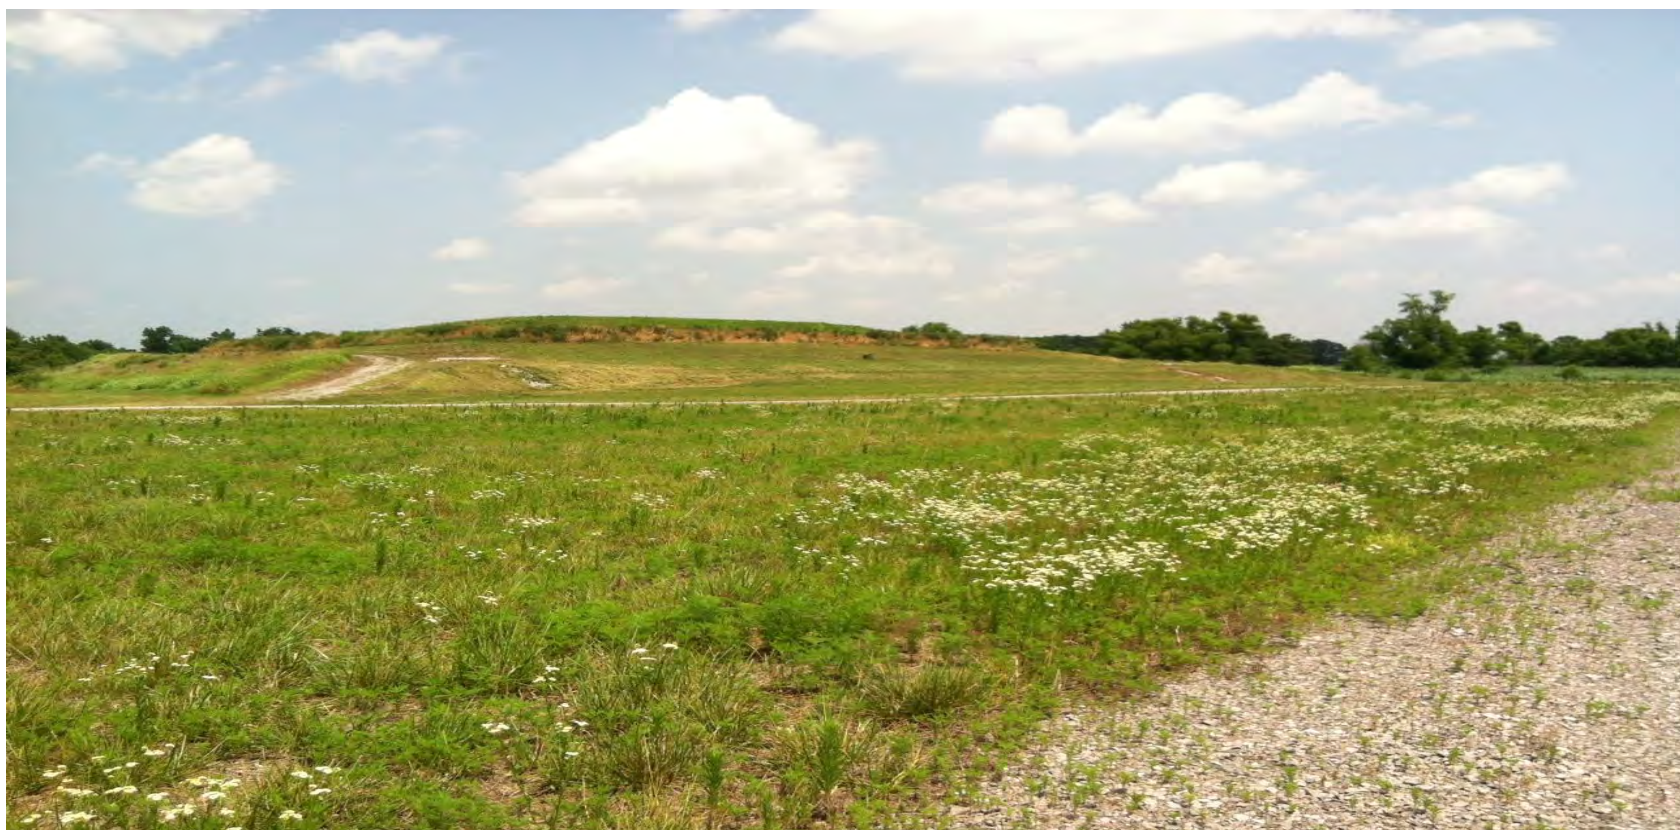
Engineered containment unit (CAMU) requires routine monitoring and inspection

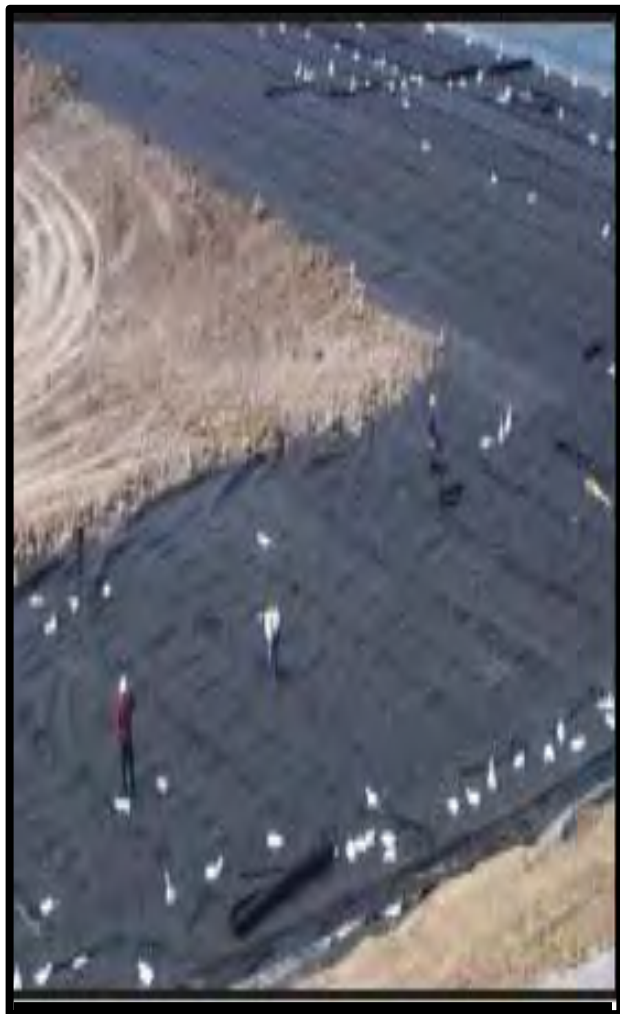
Soil Covers

Dug out some areas,  
installed containment  
unit, and 37 acres of  
engineered soil cover  
barriers - three layers

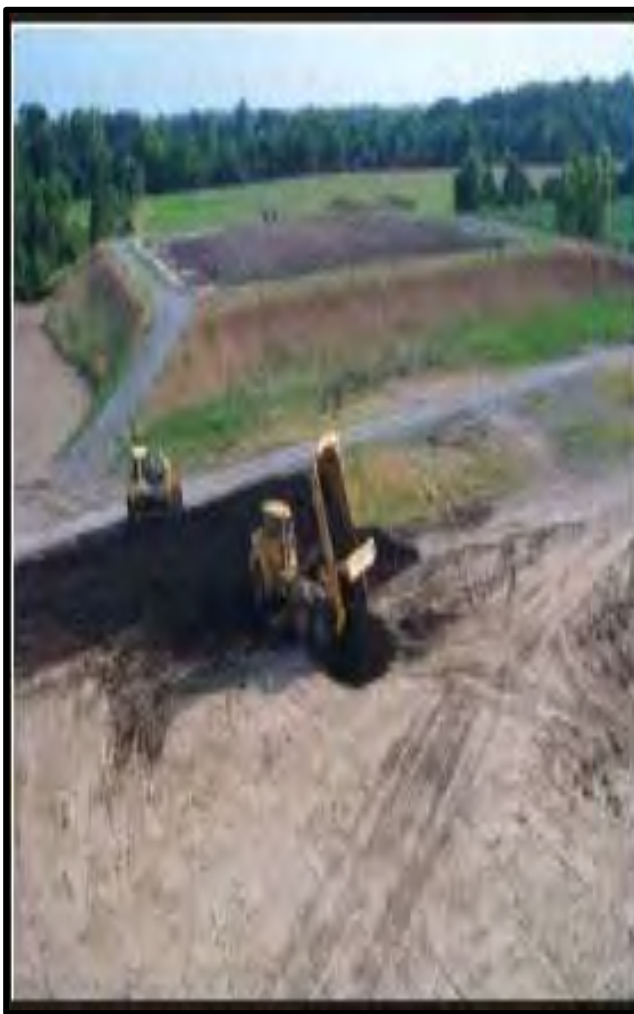
CAMU

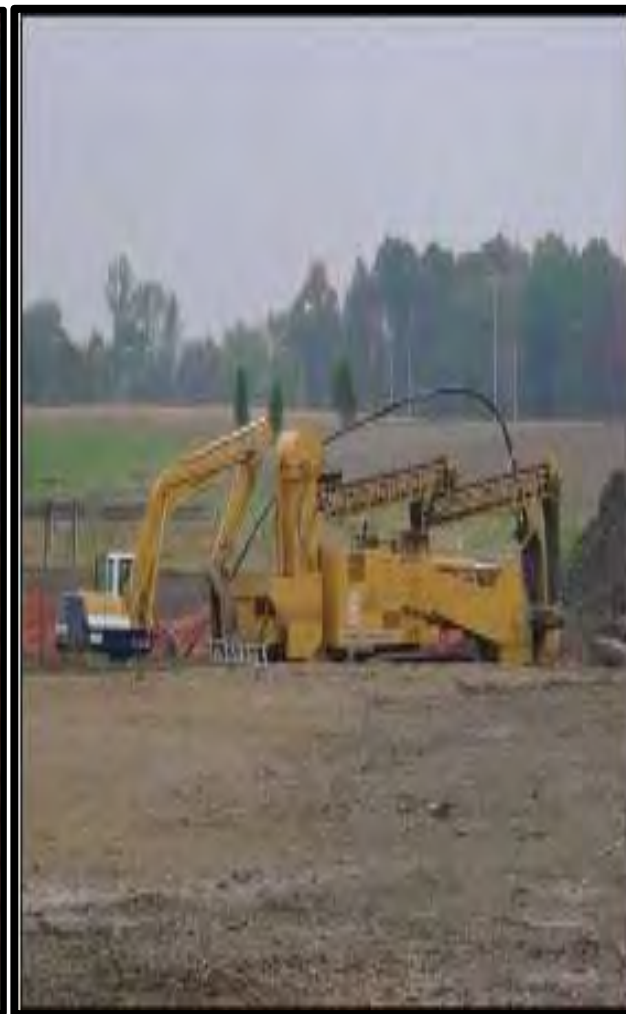
DNAPL Recovery Trench

- Glade Creek Collection Trench
- Former Operations Area Recovery Well

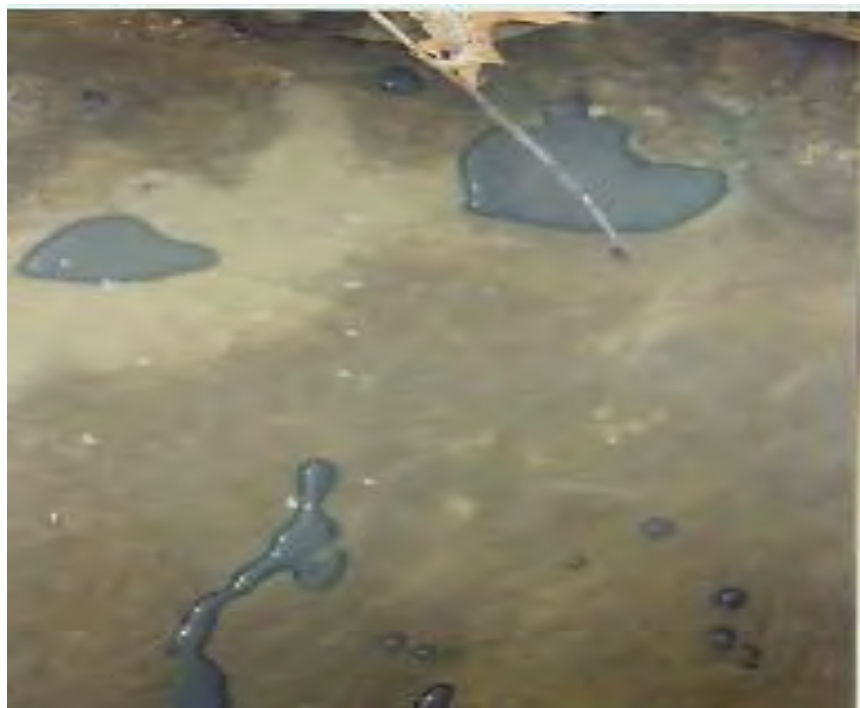
Creosote globules in water

The worst contamination was in Glade Creek, a 1939 release was mainly responsible

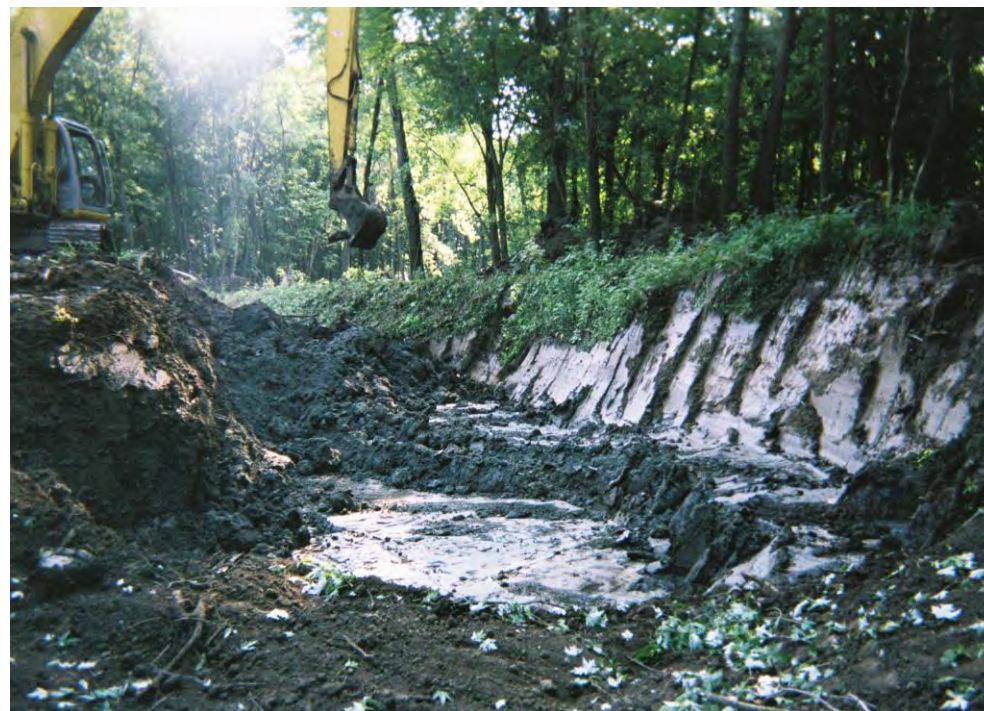
Sediment and soil saturated with creosote

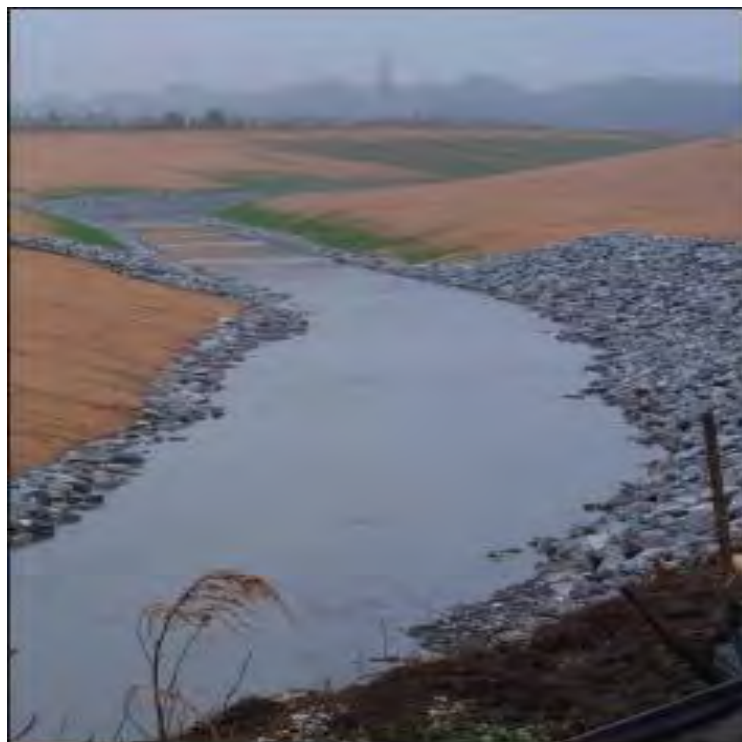
1,300 feet  
Channel Relocation

Contaminated sediment/soil stabilized with kiln dust then moved to containment unit

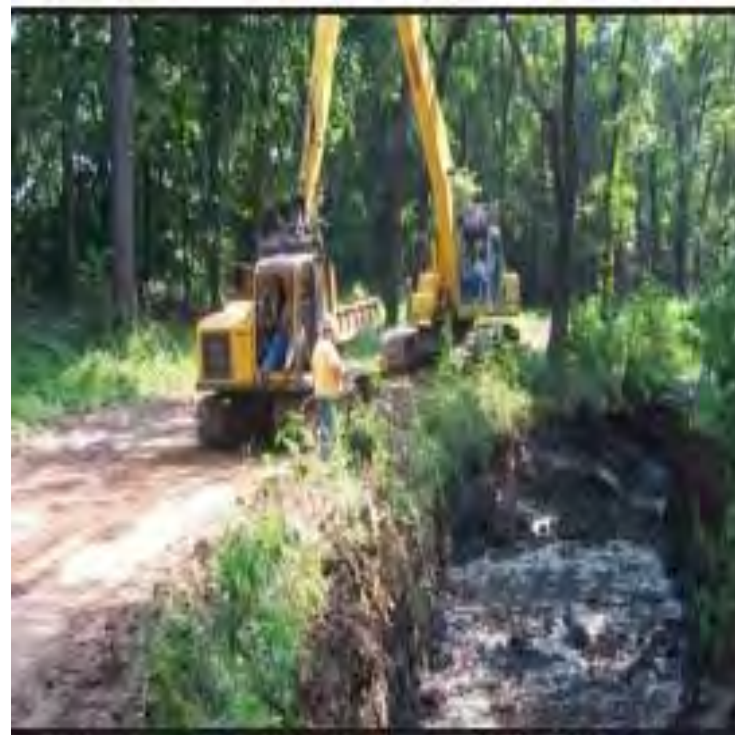
4,000 feet  
Creek Excavation

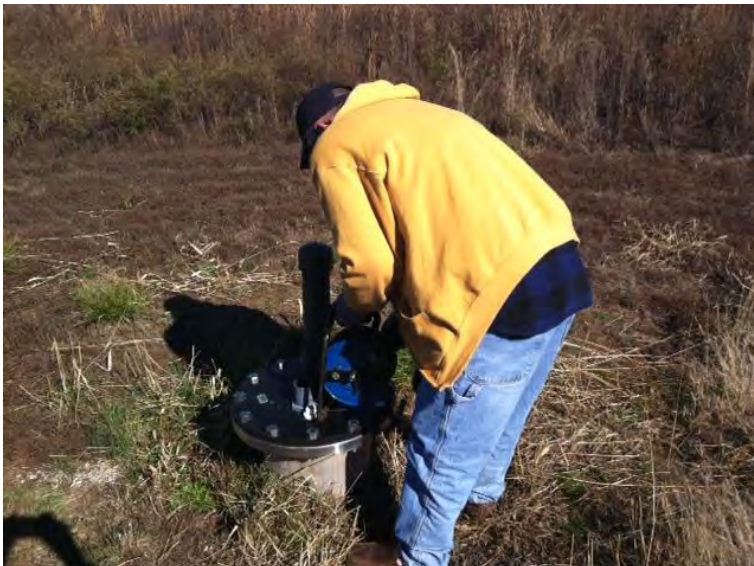
Beazer caretaker monitoring collection sump

14,500 gallons collected and sent off-site for disposal and recycling

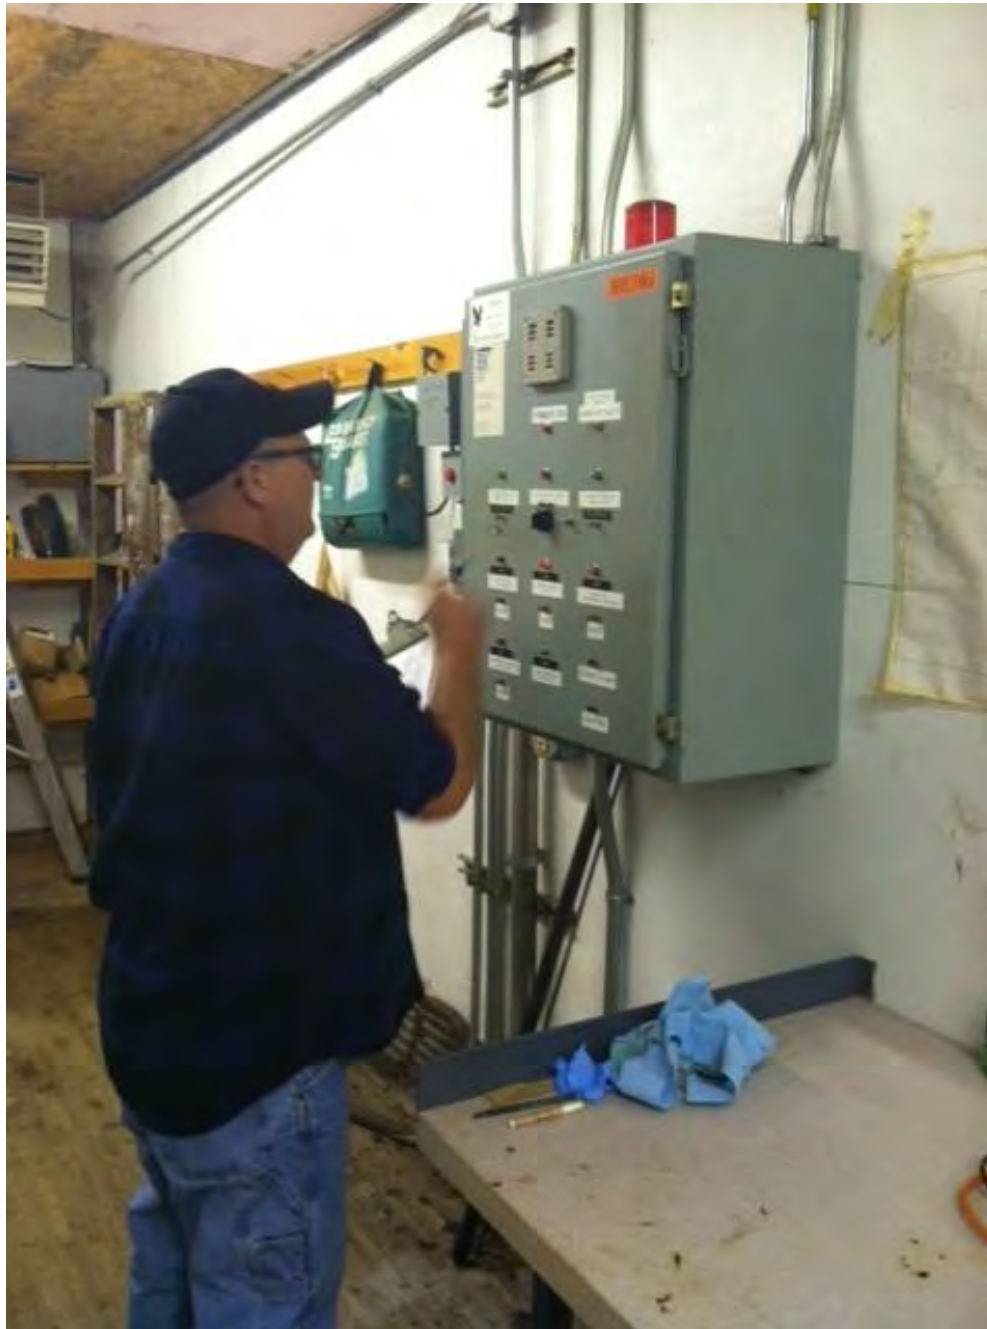
Groundwater collected with creosote is treated in on-site plant and sent to Carbondale POTW

Koppers caretaker starting up water treatment plant on the site

Plant is an oil-water separator with a carbon filter

Operated under City POTW permit conditions

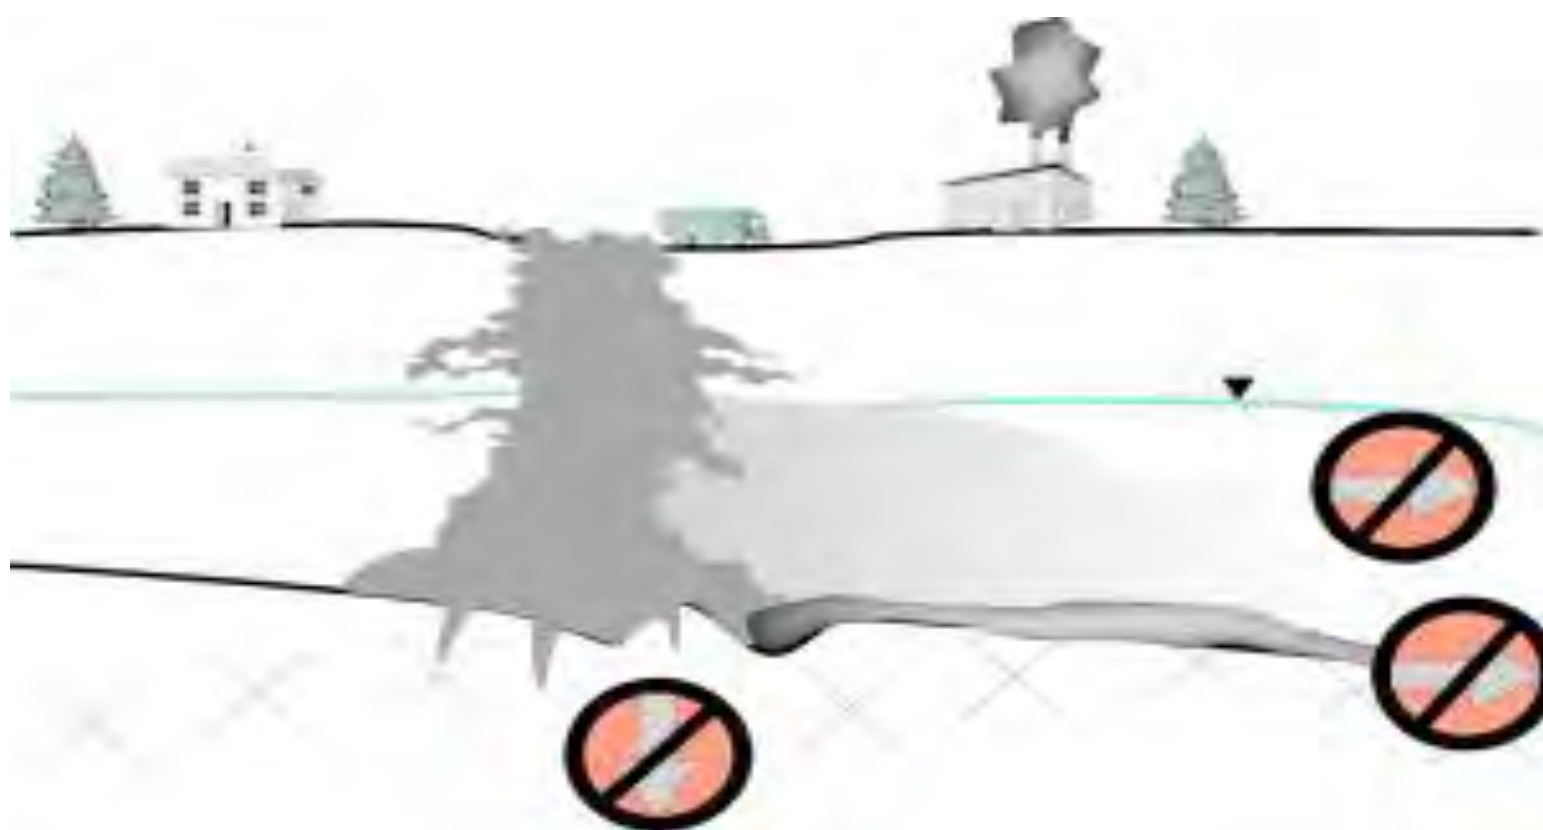
# Dissolved and NAPL Plume Example of Source Control

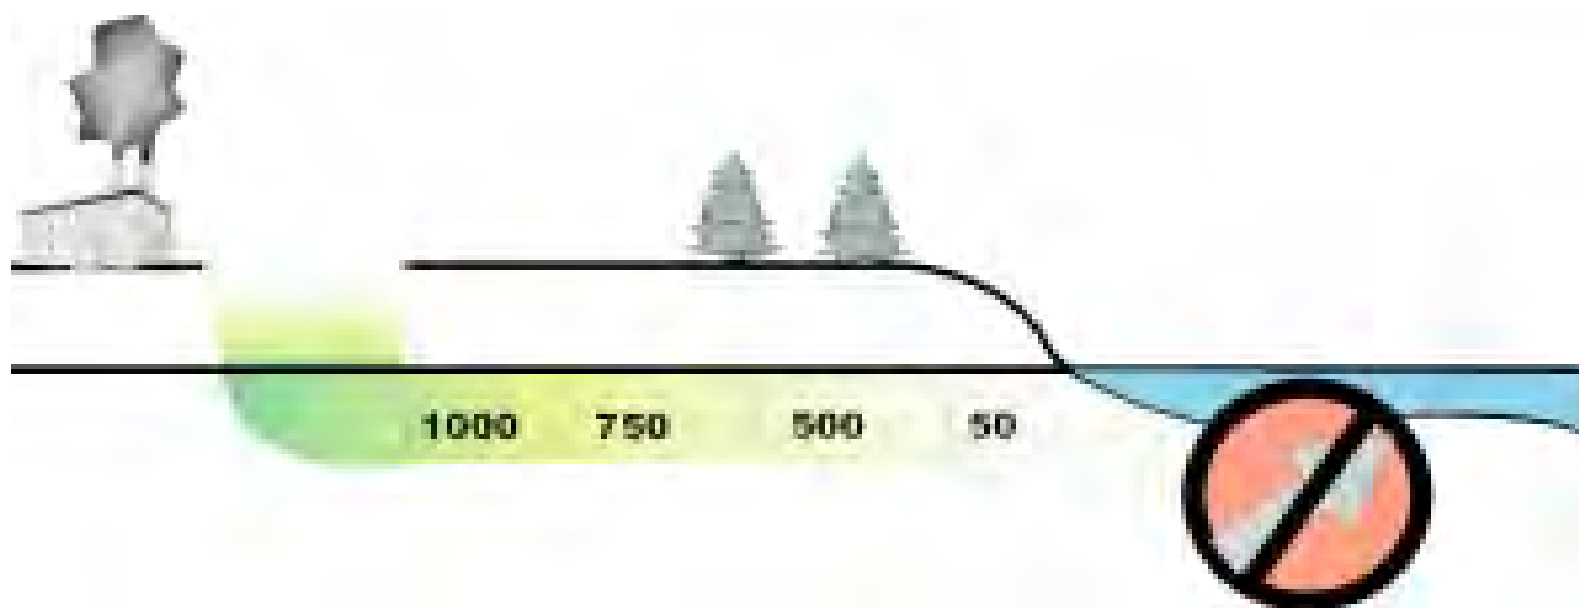
# Dissolved Groundwater Plume Discharging to Surface Water Example of Source Control
